CLUTCHTECHS) **TSB - SU02**

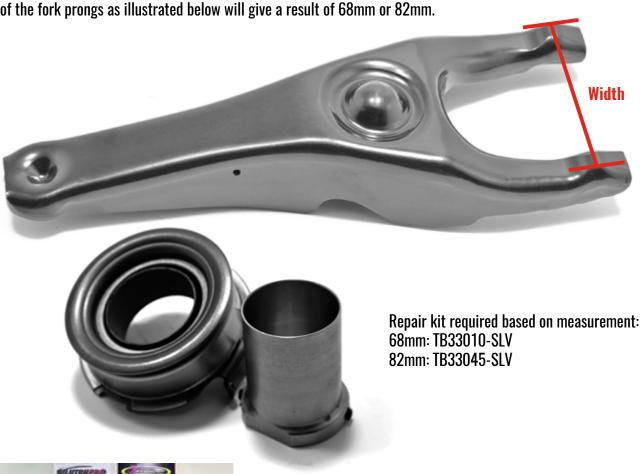
It's common for this vehicle to develop excessive wear on the nose cone (bearing slide) on the transmission. Check the nose cone visually for wear before fitting the new bearing.

Symptoms of a worn nose cone:

- Clutch Pedal Vibration
- Notchy Pedal
- Hard/ Heavy Pedal

If your vehicle exhibits any of these symptoms or visually shows wear, ClutchPro recommends fitting a repair sleeve kit. There are 2 kits available depending on the clutch fork in the vehicle. Measuring the outside width of the fork prongs as illustrated below will give a result of 68mm or 82mm.
