Please note that the factory hydraulic dampener on the PX model Ford Rangers is known to be a common failure point in the clutch hydraulic system.

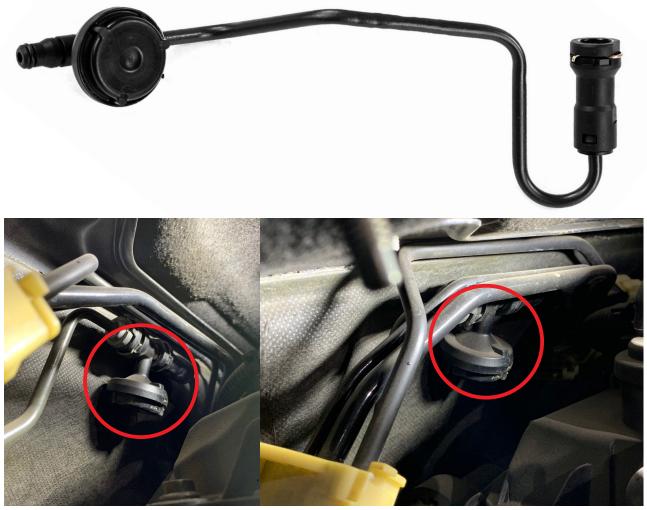
During each clutch fitment, it is important to inspect the dampener (located on the firewall) for any cracking, weeping or leaking.

Failure of the dampener can show in the following ways:

- Slowly losing pedal pressure (ie overnight)
- Complete loss of pedal pressure suddenly
- · Struggling to bleed the hydraulic system

The dampener is located on the firewall right above the rocker cover.

If you are experiencing these issues, then please inspect and replace the dampener/pipework if necessary. The replacement dampener and pipework are listed against the applicable vehicles in the ACS catalogue.
